PARTICLES of Inconel or tungsten carbide heated up to 3000°C in a jet-fuelled flame, boosted by liquid oxygen and colliding with a steel shaft at Mach 3 – welcome to the world of HVOF.

The Australian Mining Review visited High Velocity Technologies (HVT) in Maddington, WA, for an insight into this high-tech, high-temp process.

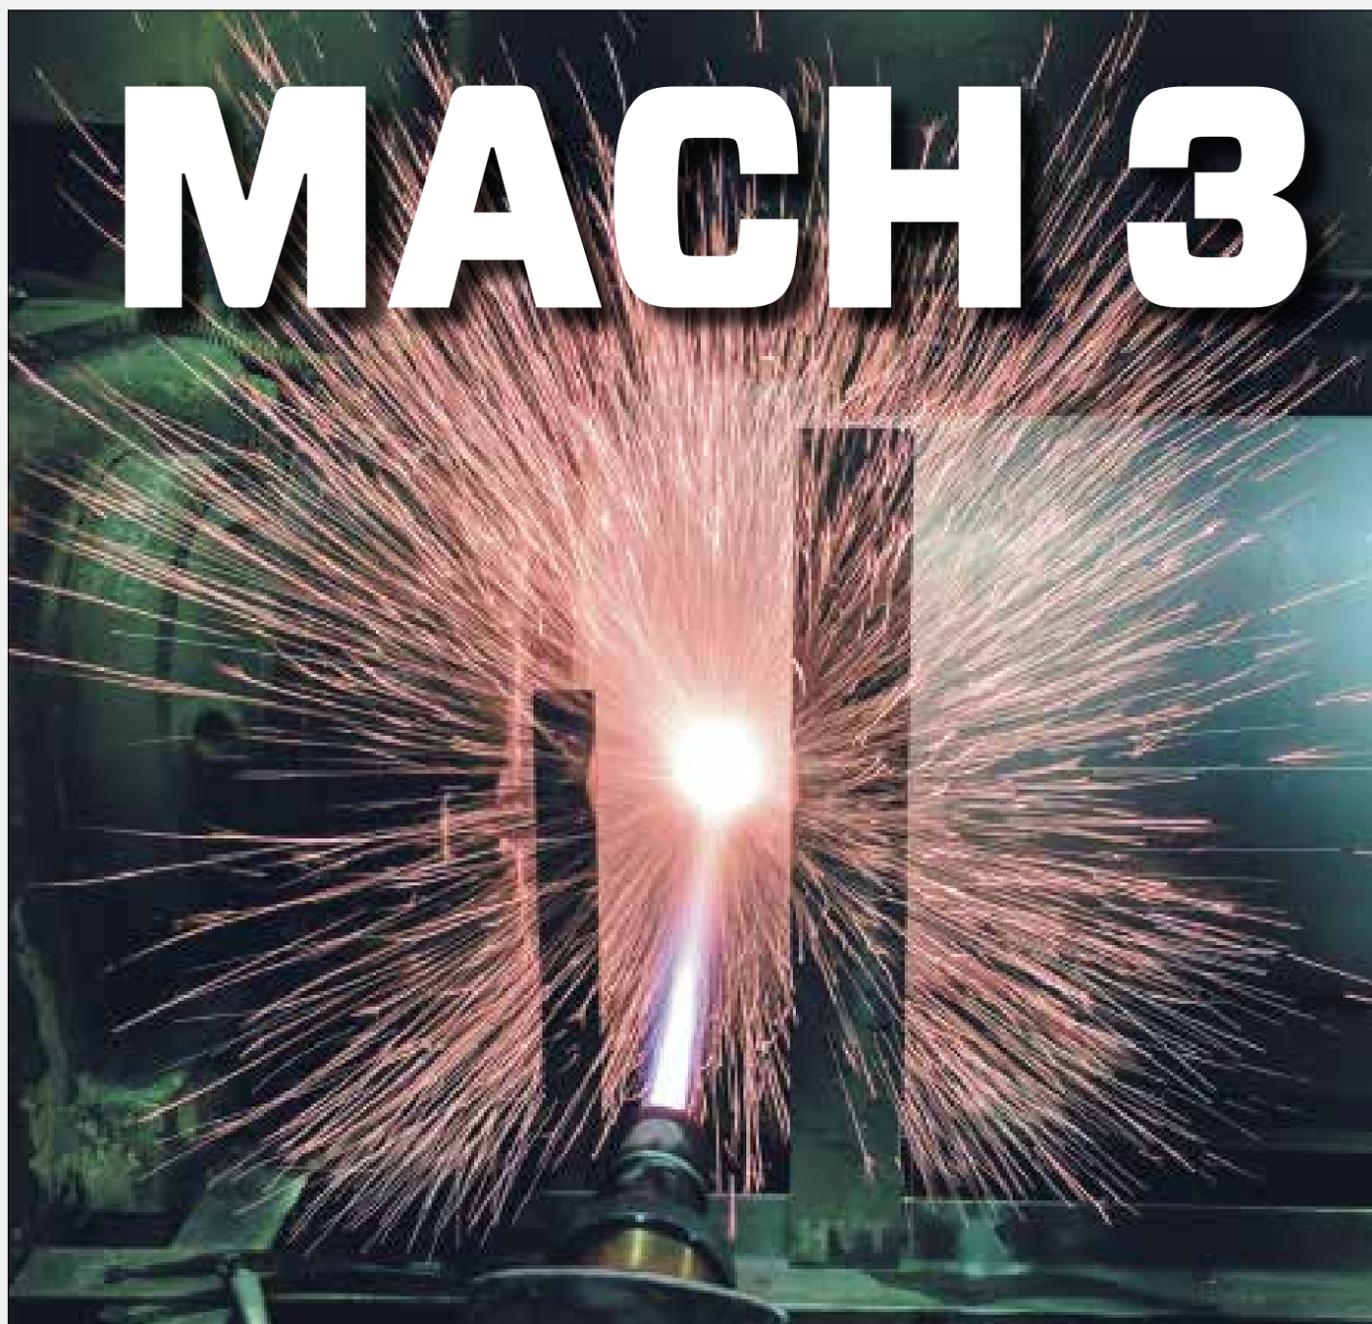
HVOF of a CAT 793 rear suspension rod wear band to improve wear resistance and increase longevity to service life. Suitable for an endless range of components and environments, there is a HVOF solution to almost every maintenance problem.

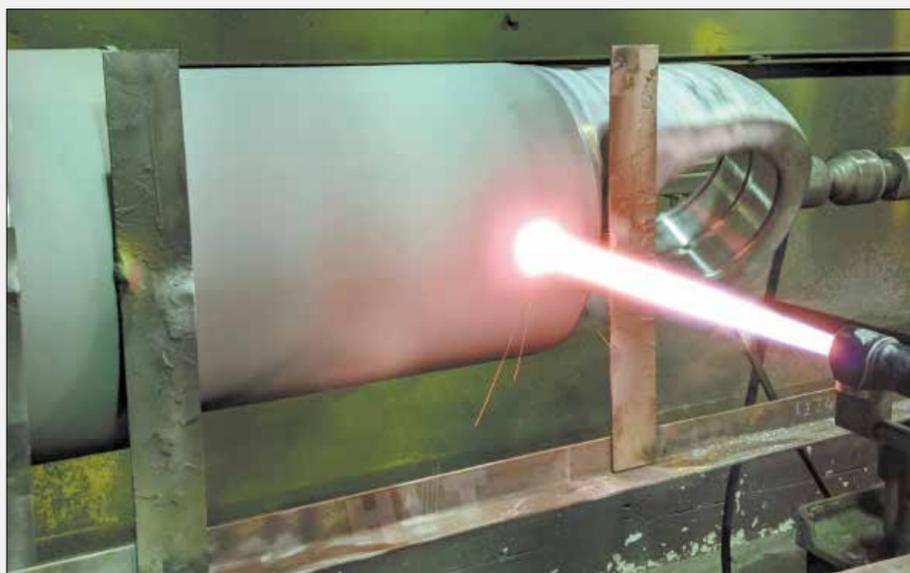
When maintenance downtime is a killer, HVOF-treated hydraulic areas (such as the CAT 793 rear suspension rod above) increases wear and corrosion resistance, providing improved service life and minimising repair requirements.

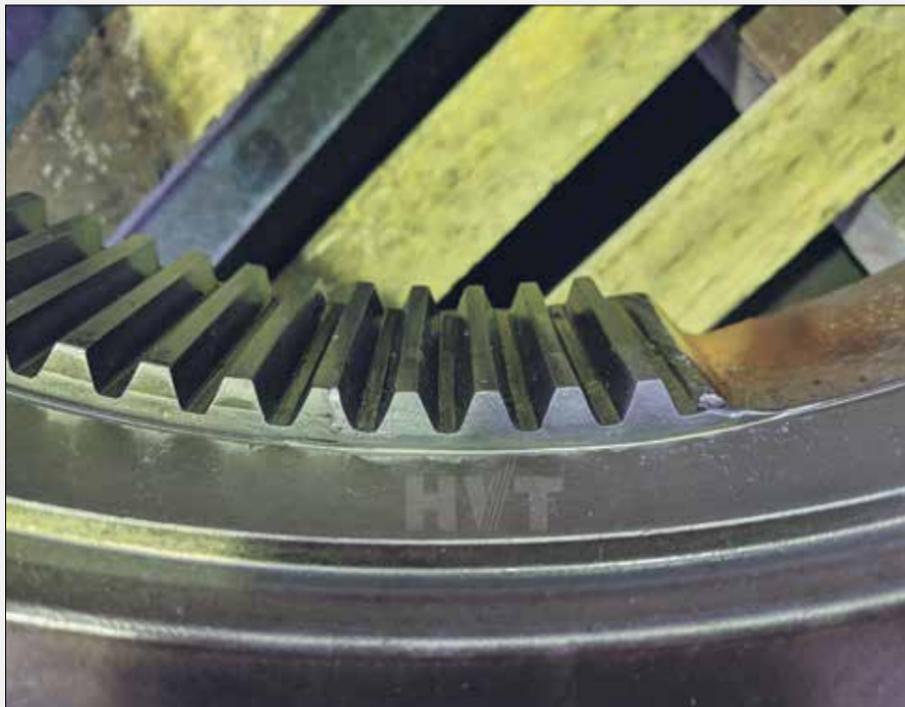
About 30pc of the splines were cracked 10-15mm down their length.

Weld repair of cracked splines on a cast iron CAT 793 extended life rear brake housing, proving a challenging solution to maintenance gaps in today's industry.

Firstly, these damaged sections were removed from the housing.

The casting was then encapsulated in a forge and pre-heated to several hundred degrees in preparation for welding.

While holding the casting at temperature for the duration of the welding process, the damaged splines were rebuilt around the diameter of the housing.

After slow-cooling, the splines were worked back to OEM specifications and non-destructive testing was undertaken to confirm the housing was devoid of cracks.

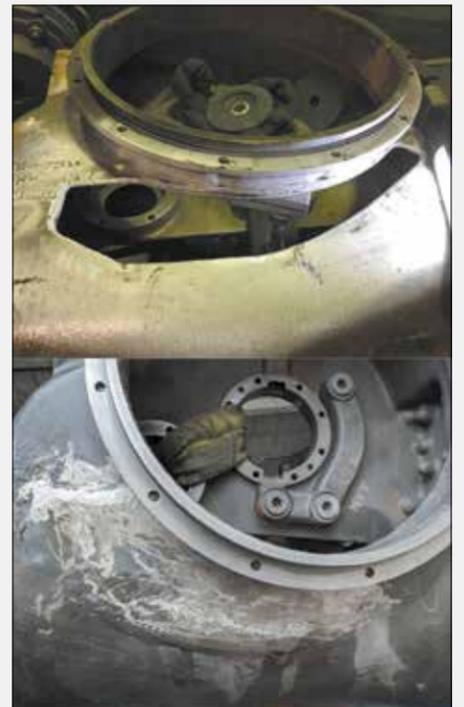
When there is no new, used will most-certainly do. A remarkable recovery of a badly damaged cast iron converter case using high-temperature forge welding techniques.

In-line with its affinity for complex repairs, HVT was the recipient of an R1300's cast iron converter case, which had already been subjected to a failed weld attempt at another service provider.

Unfortunately, an already significant hole in the housing was made worse by heat-affected zones in the surrounding area forming brittle

structures and resulting in further cracking of the housing.

To make matters worse, the housing was exceptionally warped – 6mm out of round and dropped by 3mm.

To counteract the warped housing, bracing

was designed and manufactured to re-align it with the flange faces/PCD and to support the housing throughout the welding process.

A piece of plate was fused into the housing under forge conditions and at exceptionally high temperatures – so hot the welding helmets were melting and multiple helmets were used on rotation to allow them to cool.

After days of slow cooling, the housing was successfully machined back to specifications.
